Fish, Aquatic Ecosystem Response

Recovery of Fish Populations and Physical Channel Characteristics in Streams Impacted by Catastrophic Debris Flows

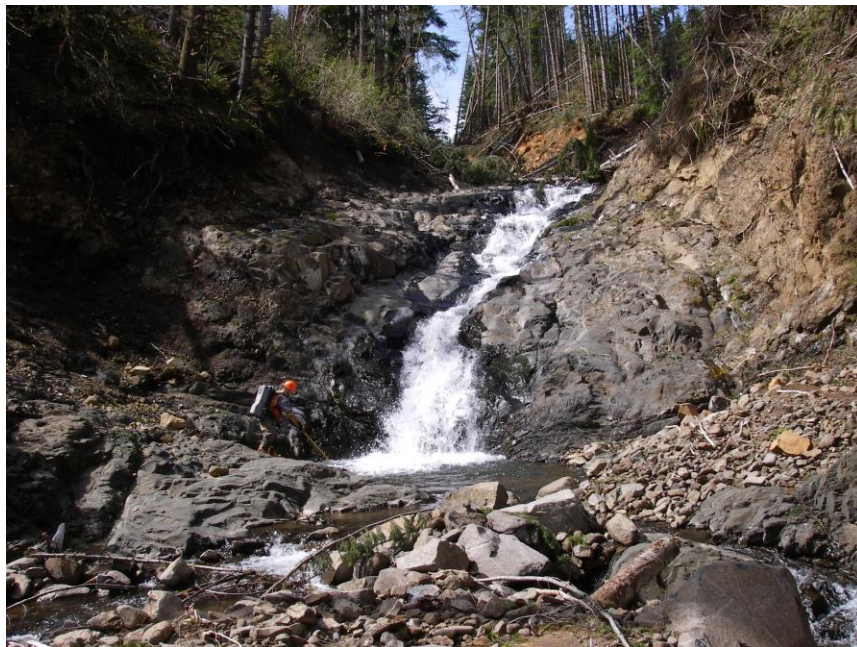
Example of a stream channel in the upper Stillman Creek basin impacted by a catastrophic debris torrent caused by the December 2007 storm.
